UNITED STATES ARMY TRANSPORTATION BOARD
Fort Eustis, Virginia

FINAL REPORT

PROJECT LEAD DOG 60

A TRAVERSE OF NORTH GREENLAND AND AN
AERIAL AND SURFACE EXPLORATION OF
PEARY LAND AND CROWN PRINCE CHRISTIAN
LAND CONDUCTED BY THE US ARMY TRANS-
PORTATION CORPS MAY-JULY 1960

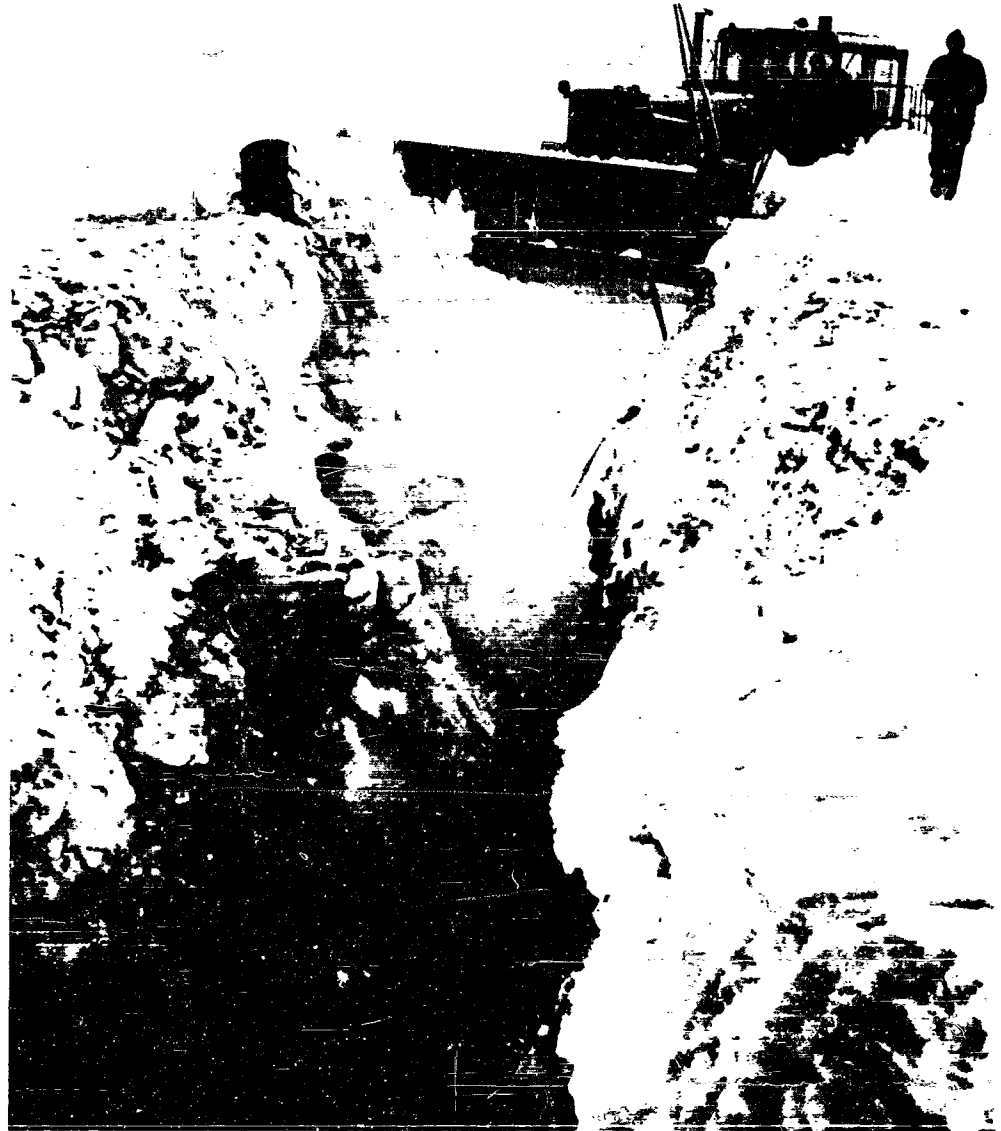
Figure 20. D8 tractor fills open crevasse at Mile 12.

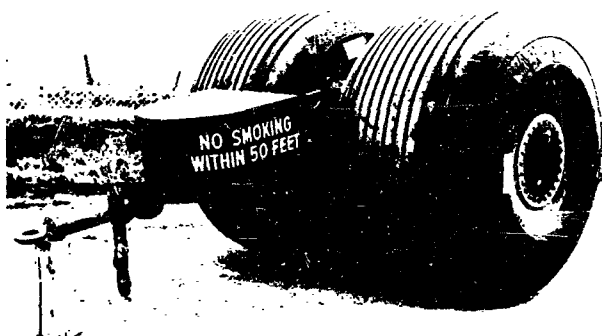
TRANSPORTER, LIQUID, ROLLING WHEEL TYPE,
1000 GALLON, T-3

Note: All dimensions shown are in inches.

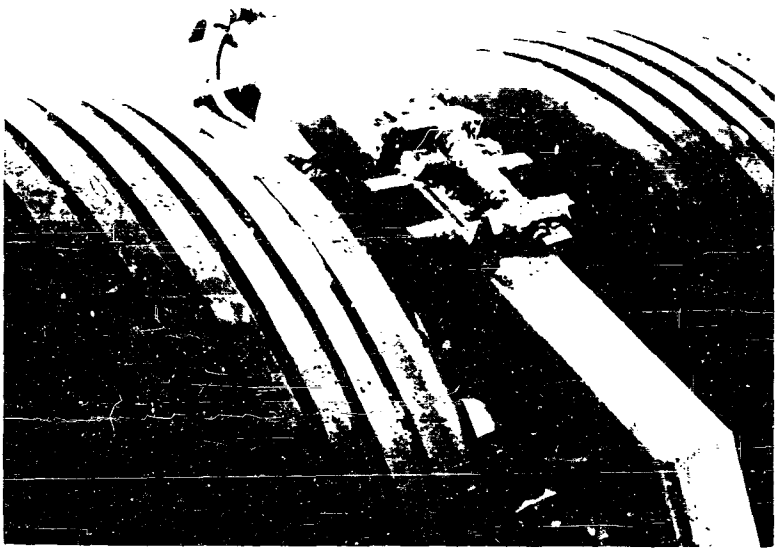
Figure 32. Failure to Rolli-Trailer goose neck occurred at Mile 231 on the return trip.

The goose neck on the Rolli-Trailer failed at Mile 231 and the trailer bed and its RLTs were loaded on a sled.

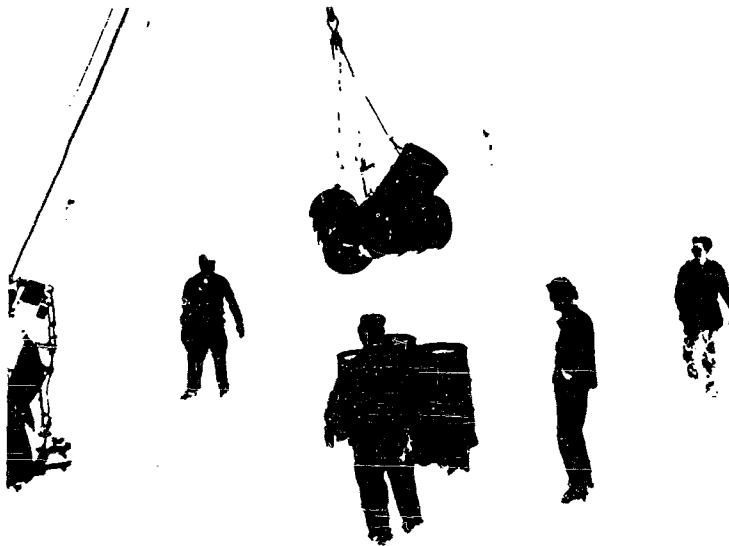
Figure 36. Hyster Hoist mounted on the rear of D-8 tractor greatly facilitated the loading and unloading of drummed fuel.

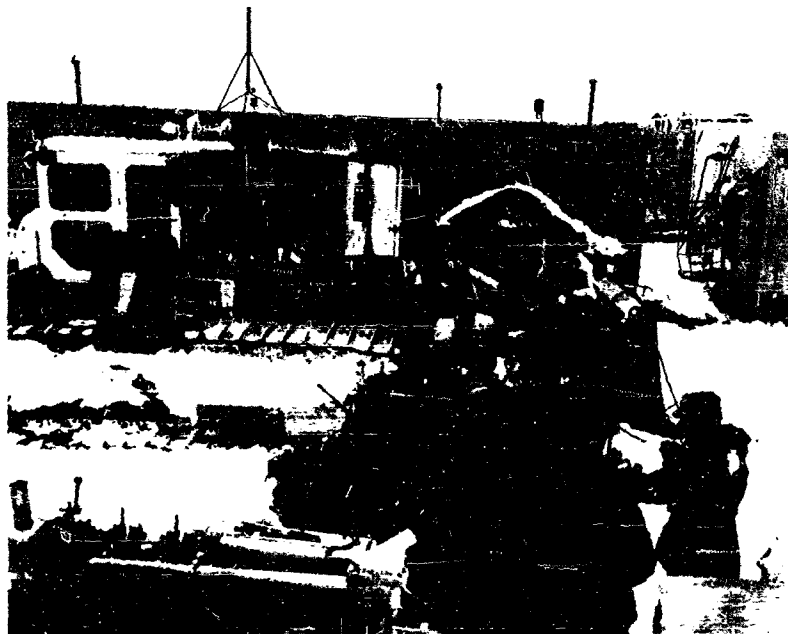
Figure 37. Mechanics replace engine in disabled tractor at Mile 481.4.

The swing maintenance personnel began, immediately after the swing's arrival at the junction, to effect the replacement of the engine in tractor T-1. While the mechanics were working on the engine, the remainder of the swing personnel refueled the tractors and RLTs; remade the swing; replaced the rear RLT unit on the Rolli-Trailer (the unit was showing numerous cracks on the inside bead of both cells); performed necessary maintenance on all vehicles; and cached seven sleds, two tractors, three RLTs, one Weasel, and all fuel and supplies not needed for the movement to Mile 124.2P.
